NARRATIVE INSPECTION REPORT DOCUMENT

EPA-DLPC

Date of Inspection: 4-19-89 Inspector: L. Papillon
Site Code: 0 3 1- 6 0 0- 0 0 3 4 County: Cook
Site Name: Land & Lakes #3 Time: 7:50am to 9:45am

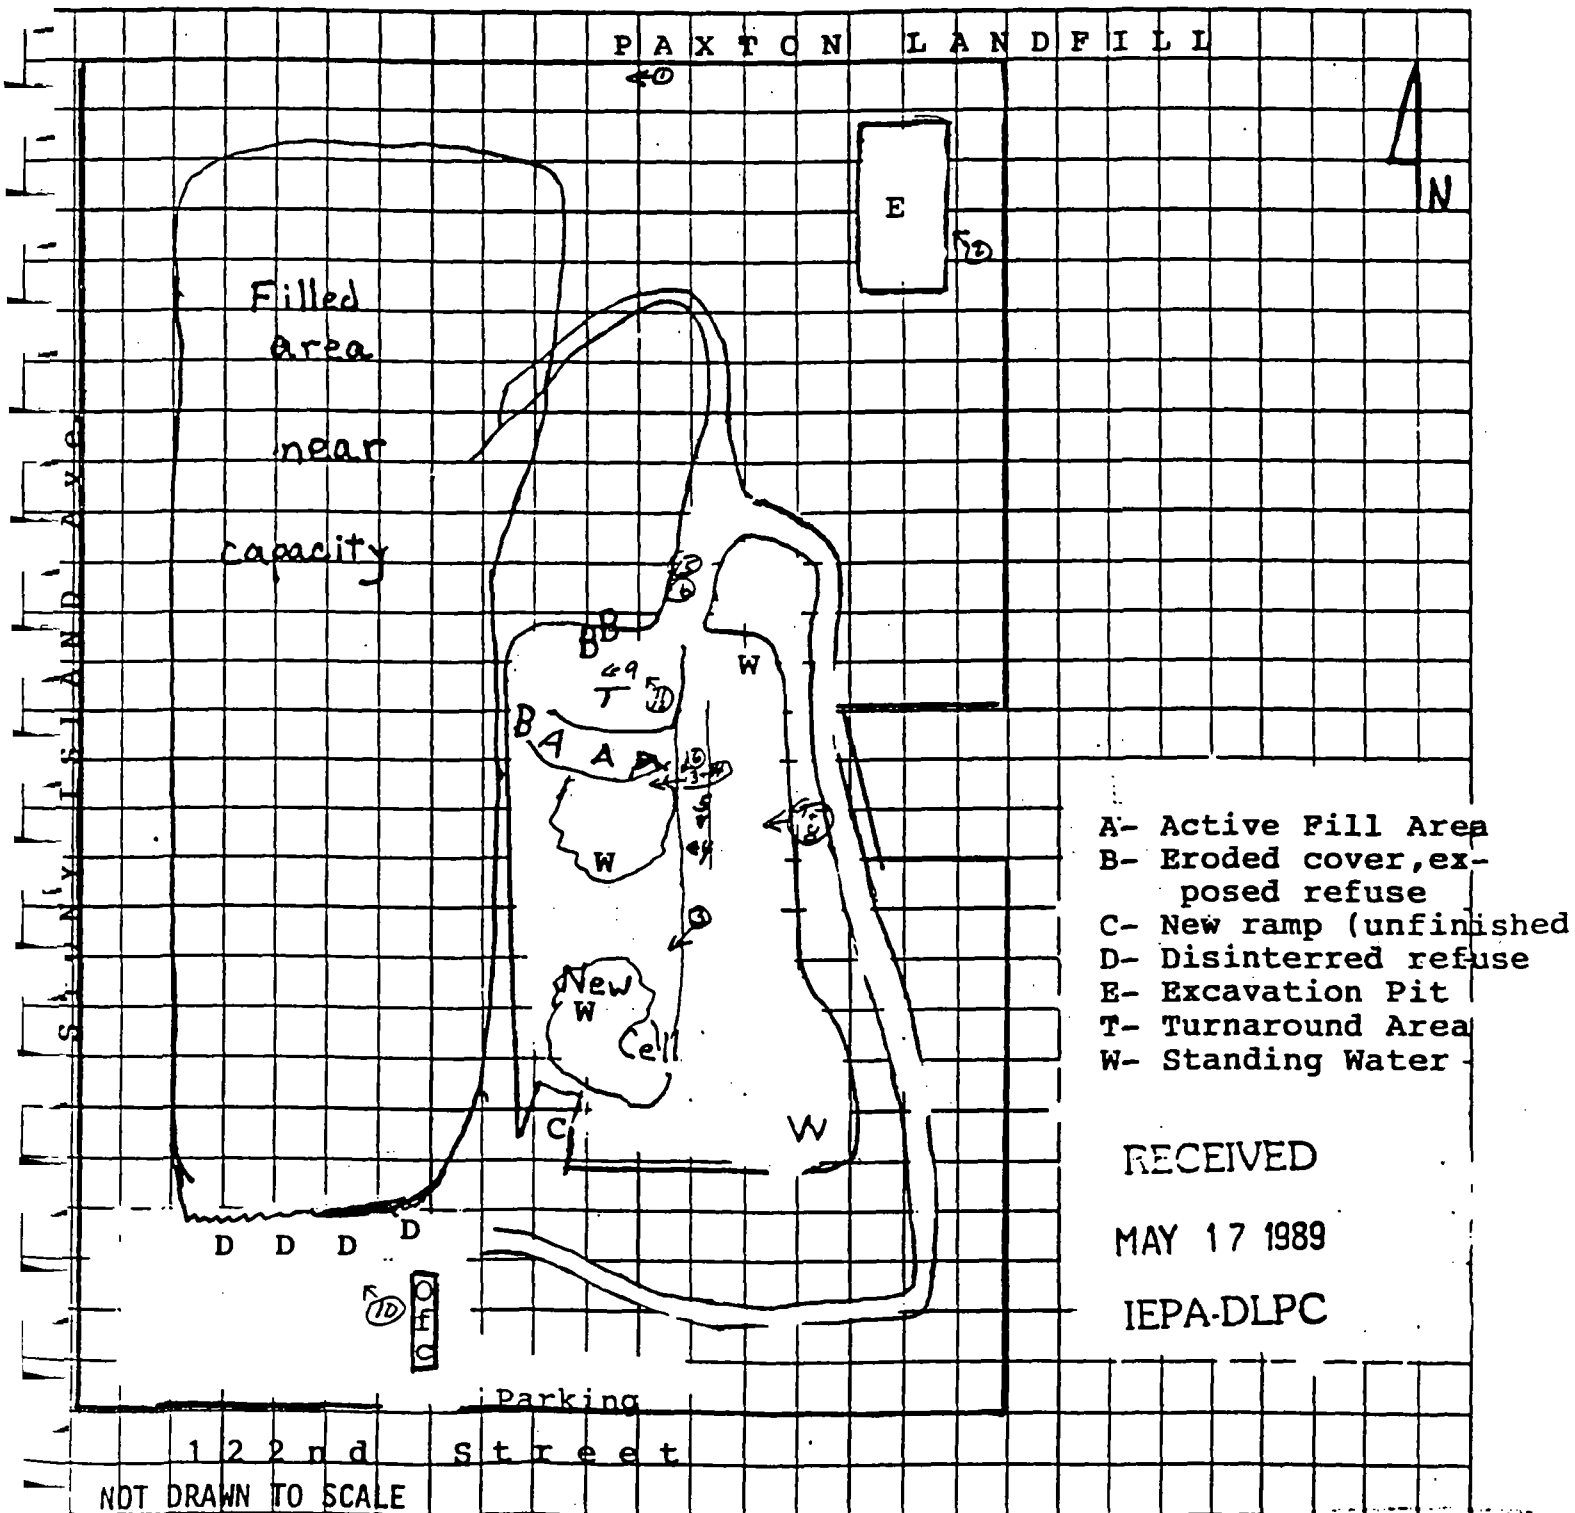
SITE SKETCH # 1

Land and Lakes excavated a pit 40 ft. X 50 ft. in the NE corner of their property (Area E on site sketch)to acquire clay for cover, according to Don Hopkins. This pit flooded with water from the east (photo 2). Mr. Hopkins claims he observed water leaking onto his property from the NE in three rivulets which collected in puddles on Land and Lakes property last September (1988). The water streams were discovered when Land & Lakes was realigning surface drainage ditches on their property. In excavating for clay, old refuse consisting primarily of bottles, tin cans and broken glass was unearthed and placed in piles by the side of the pit (photo 2).

Active fill has shifted to a new cell approximately 360 X 250 ft. on the eastern half of the property. (photos 3 & 4) Photos 5 and 6 show portions of the area which will not receive refuse for some time. Standing water was observed in the extreme SW corner of the cell, where a pump was removing water; most of the western half (where active fill was occurring); and in the NE corner. (photos 7, 8)

Access to the new cell is via a perimeter road along the south side of the property, north along the eastern property boundary then west and south into the cell. A second access ramp near the office (C on site sketch) was one-third complete (photo 3).

Line 6, 8: Intermediate cover from a previously filled cell eroded because excavation occurred too close to the east wall of the old landfill, exposing refuse which was buried some time ago. (B on site sketch) Photo 9 shows layers of exposed refuse along the west cell wall about 30-40 ft. above the cell floor.

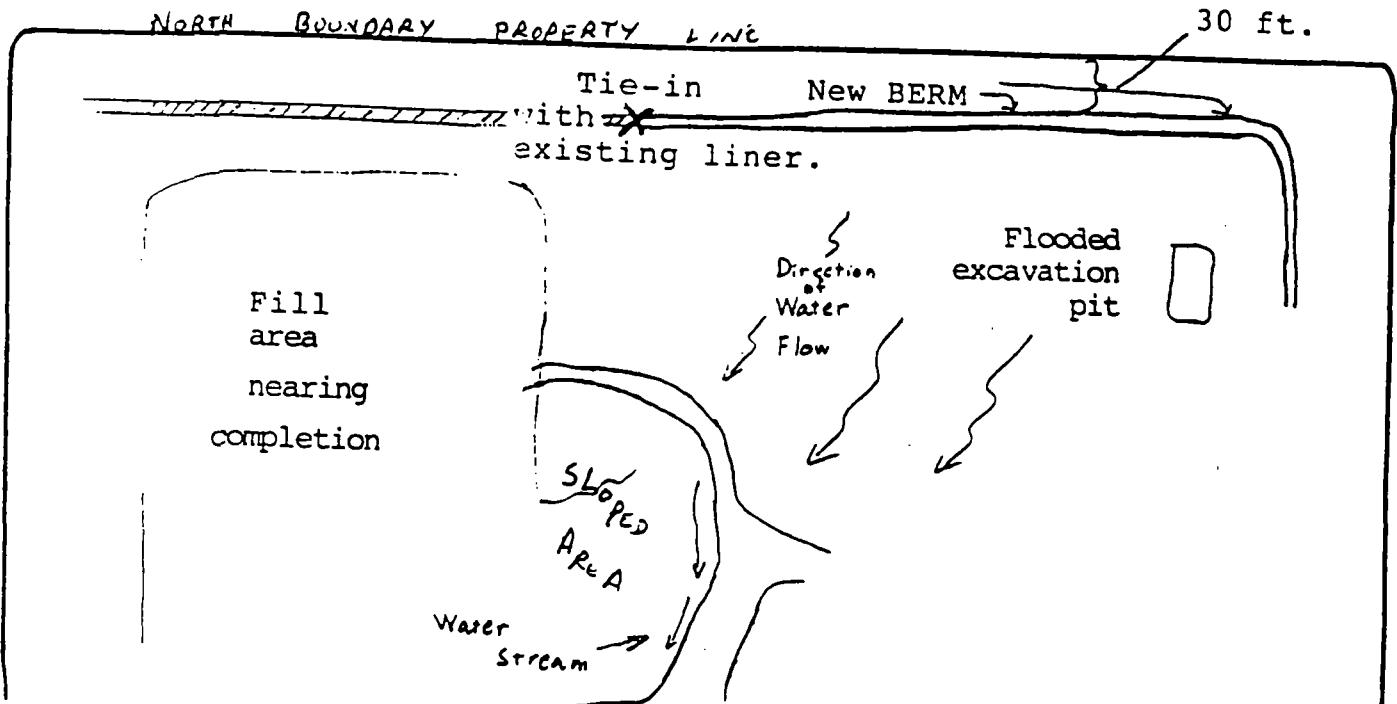
SITE SKETCH # 2

Don accompanied me on an inspection by foot along the northern boundary of the landfill. Leachate was observed seeping up from the ground around a well Don identified as a Paxton well. Dan Wiewyrk of Land and Lakes later confirmed that there is a problem with water flowing onto Land and Lakes from the N/NE. The water flow, according to Dan and Don occurs within the first 1 to 5 feet below the surface of the ground. Land and Lakes hopes to divert this water flow so it doesn't enter their property by constructing a clay berm from the existing clay liner cell in the north center of their property east to the eastern property line (see sketch 2). The clay liner/barrier will run west to east parallel to--and 30 ft. south of--the northern property line. The "berm/liner" will average between 9-11 ft. in depth, be 30 ft. thick at

Map of New berm/barrier construction designed to prevent flow of water from off-site N/NE direction onto Land and Lakes #3 property.

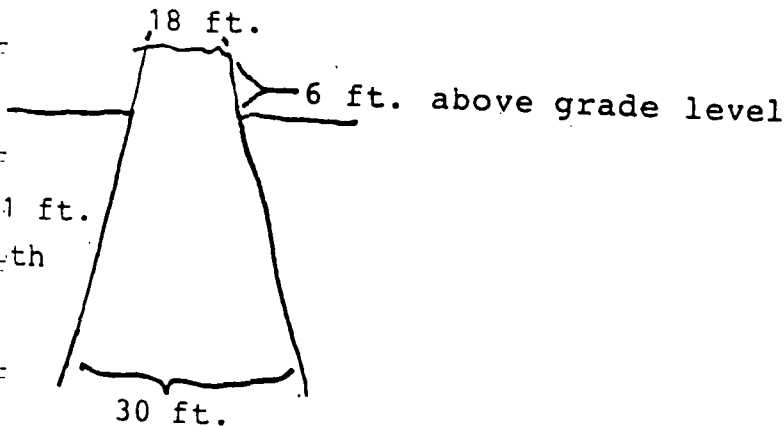
Profile of water barrier berm.

the bottom, and taper to 18 ft. thick at the top where it will also rise 6 ft. above grade.

Existing Liner
New berm
